- Rapid Ordinary High Water Mark (OHWM) 1.0

Project	21028 Hoffman Falls Wetland Delineation
ID	352398
Survey Date	06/01/2023
User	Rachael Foote

Towns of Fenner, Nelson, Eaton, and Smithfield, Madison County, New York

Wetland and Stream Delineation Report

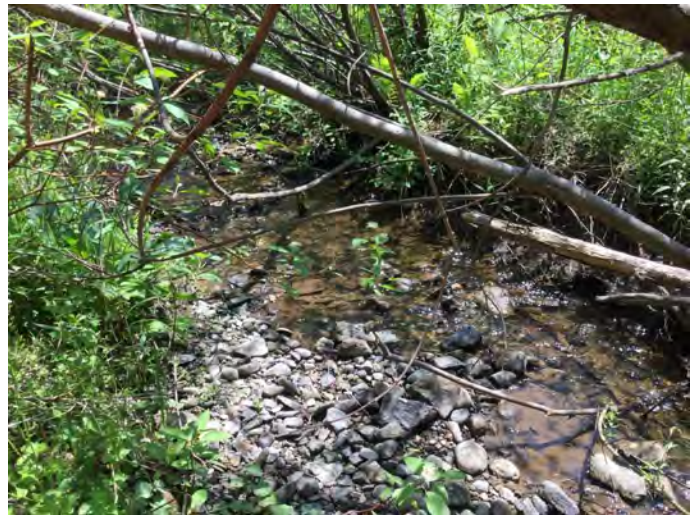
Upstream photograph.

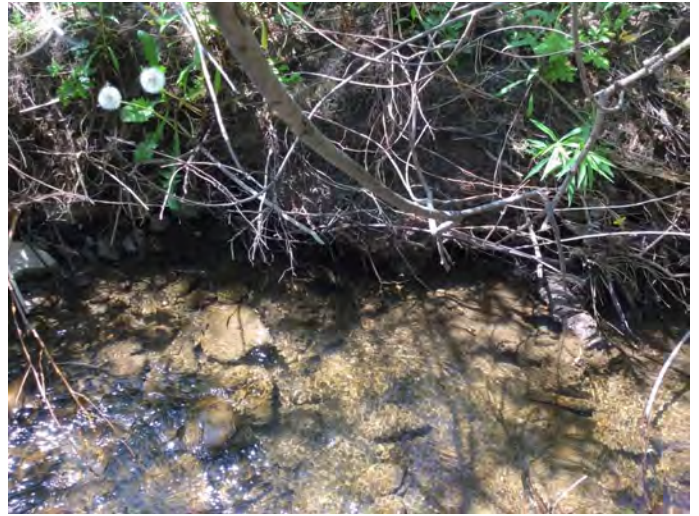
Undercut bank.

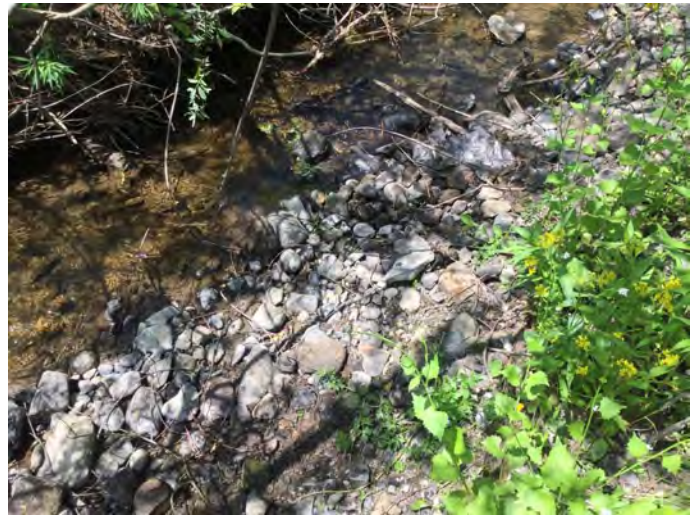
Transition in substrate type and point bar.

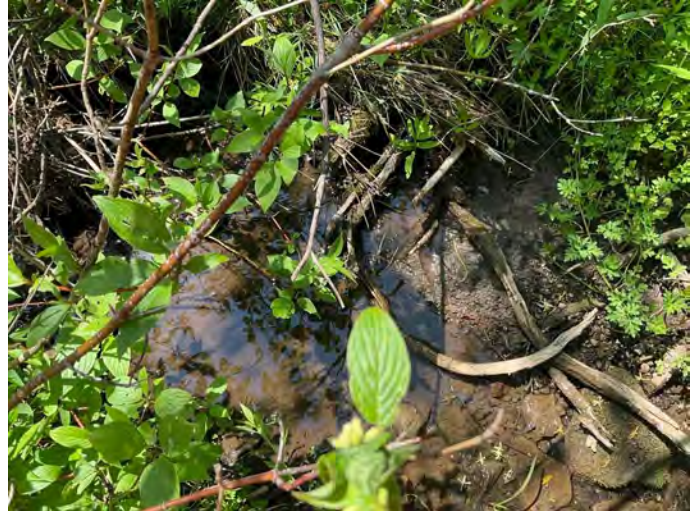
Dense vegetation within stream channel.

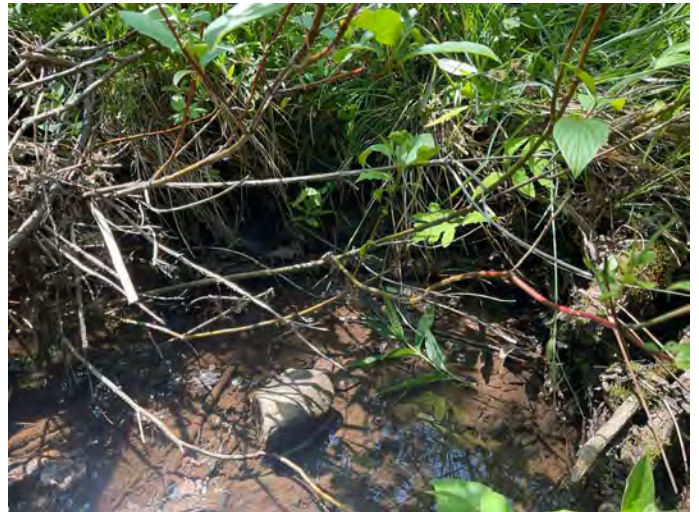
Streambed and substrate with break in slope and transition in vegetation present.

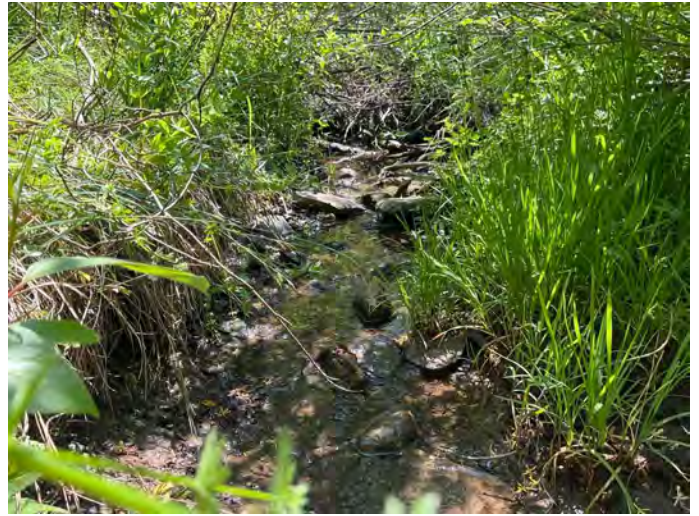
Photo of stream flowing within the PSS wetland complex.

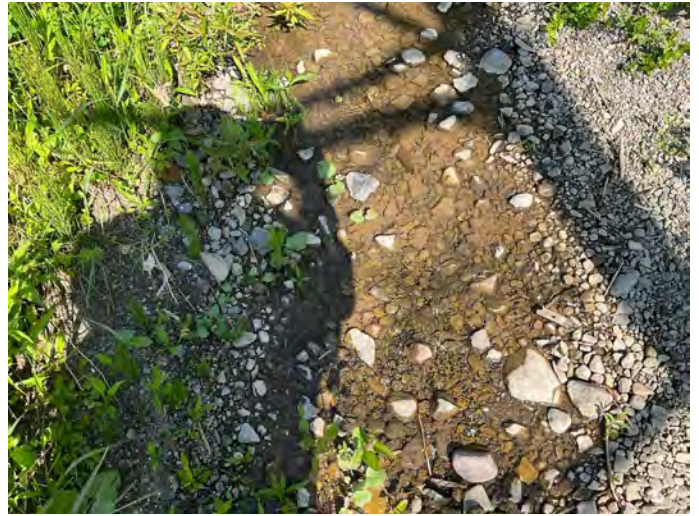
Upstream photo, with vegetation transition present.

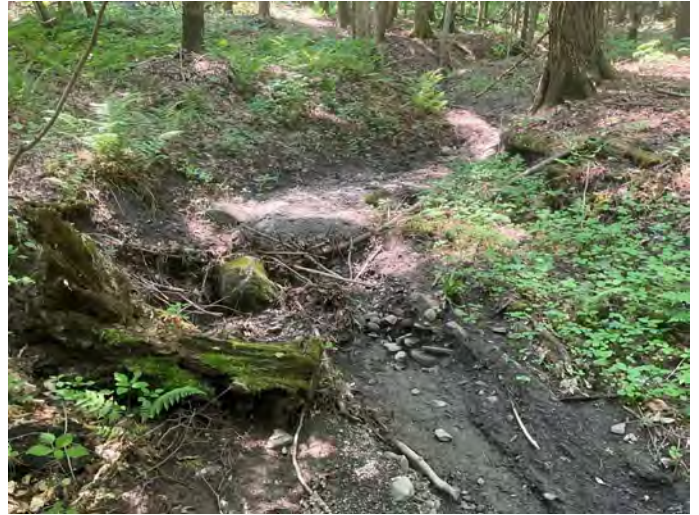
Break in slope, change in particle size distribution.

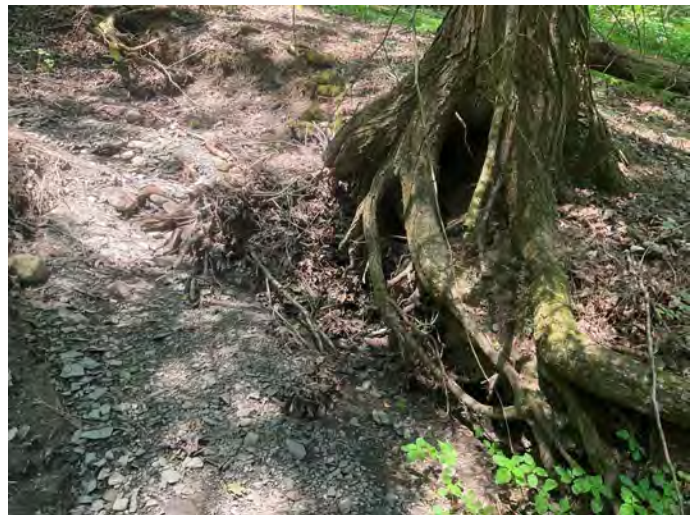
wracking, change in particle size distribution, break in slope.

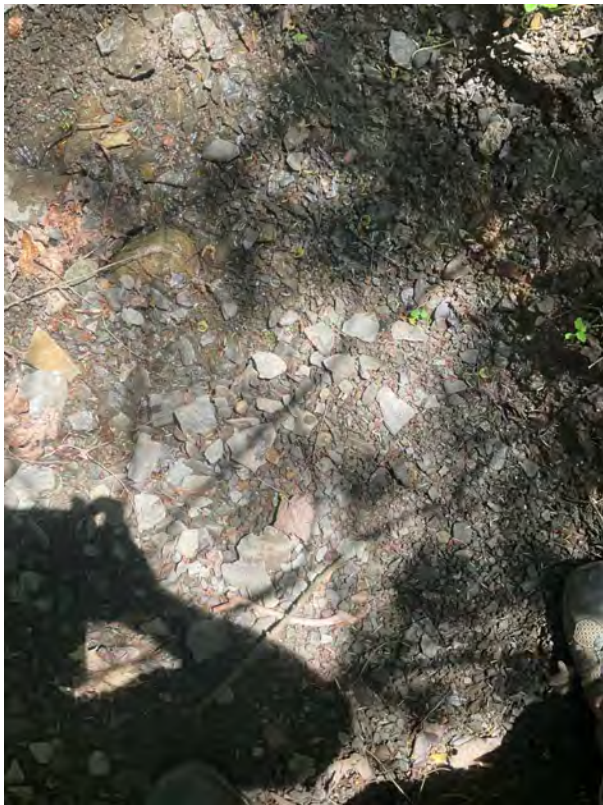
break in slope, intact roots,

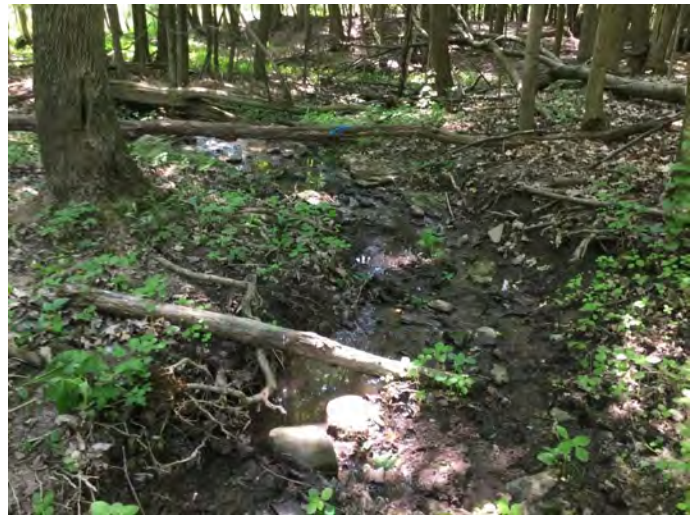
Upstream photograph with break in slope and vegetation transition present.

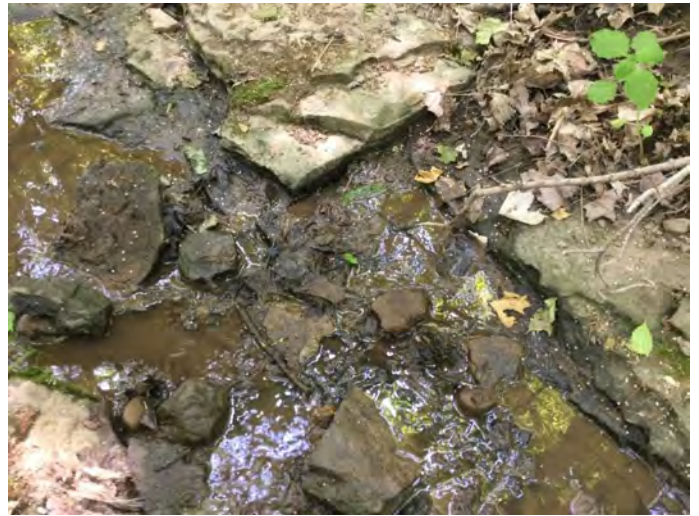
Presence of woody material above the OHWM.

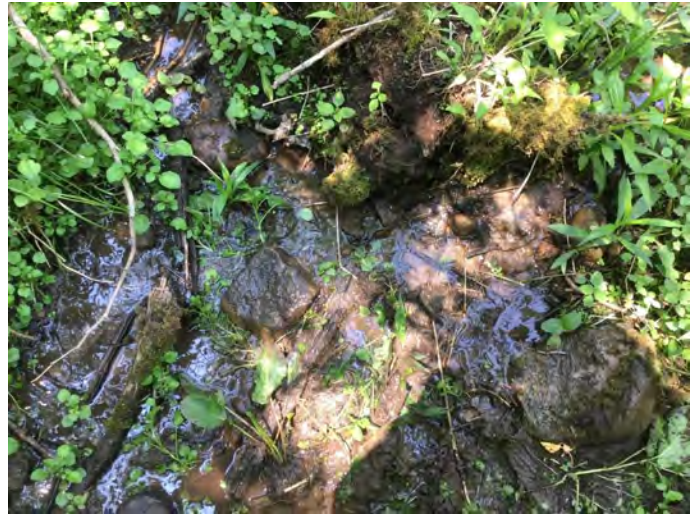
Stream substrate, with water staining above the OHWM.

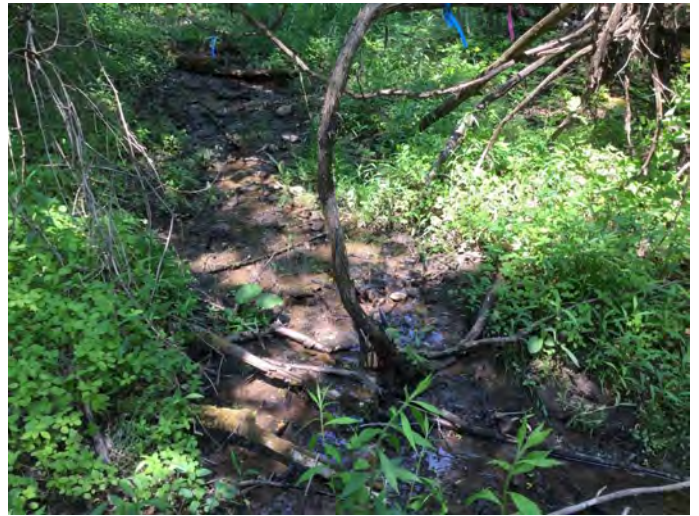
Upstream photograph with transition in vegetation.

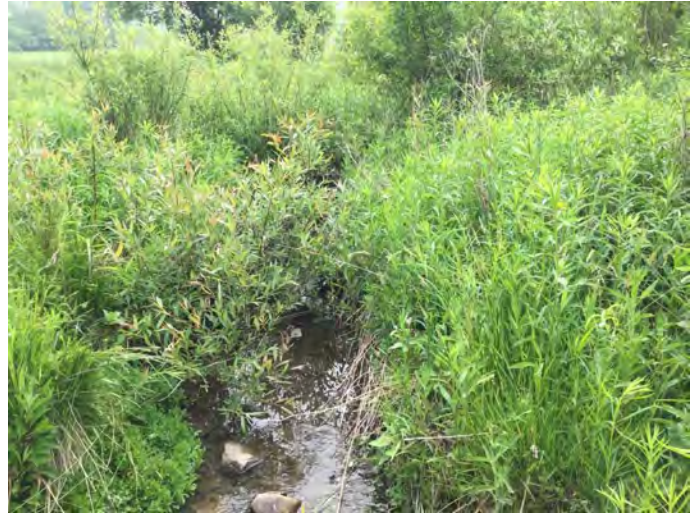
Break in slope, change in particle size distribution, change in vegetation type and density.

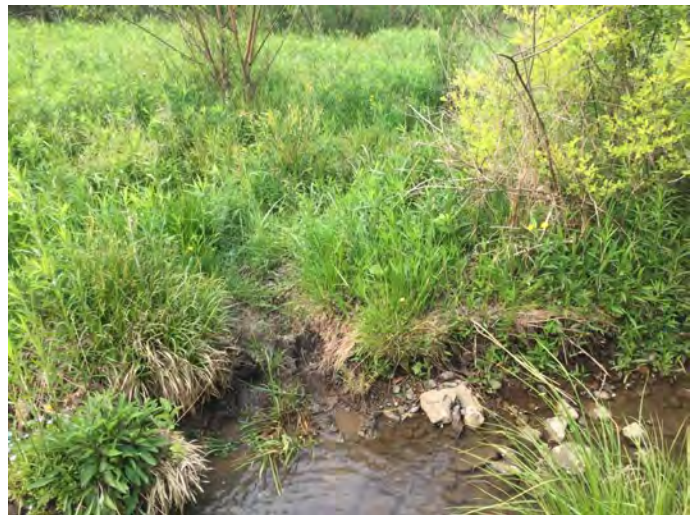
Break in slope, change in particle size distribution, change in vegetation type and density.

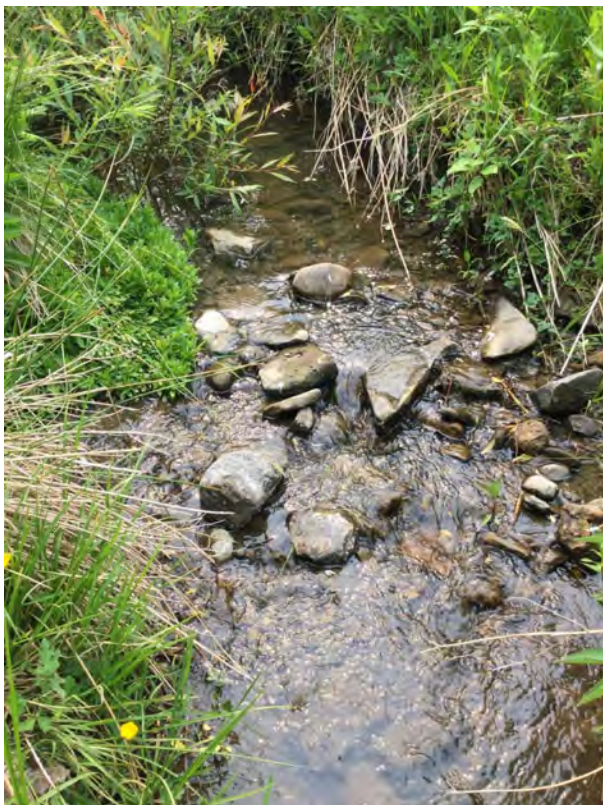
Break in slope, change in particle size distribution, change in vegetation type and density.

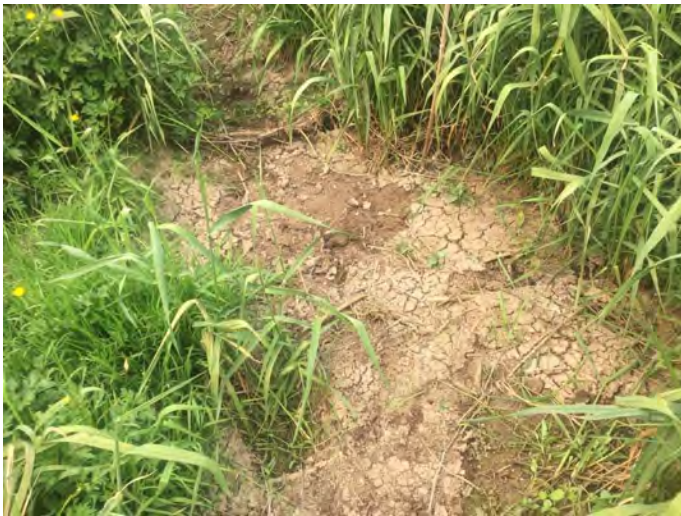
Mud cracks.

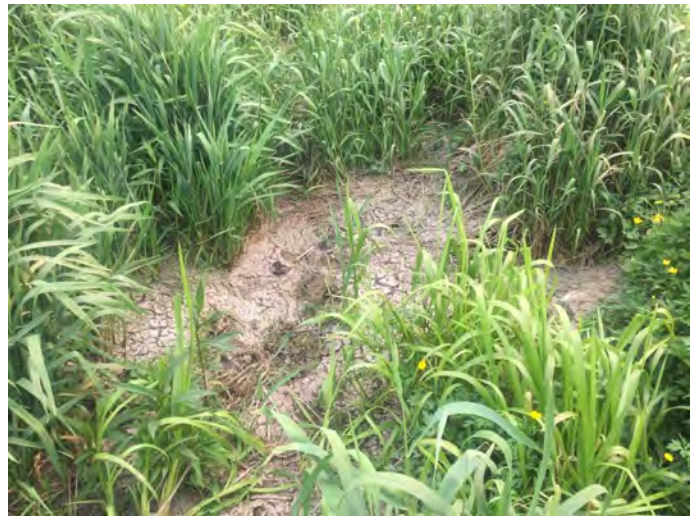
Mud cracks.

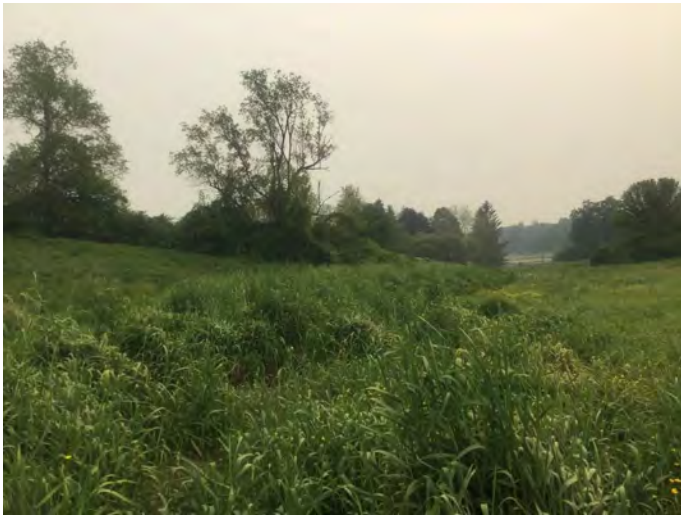
Break in slope

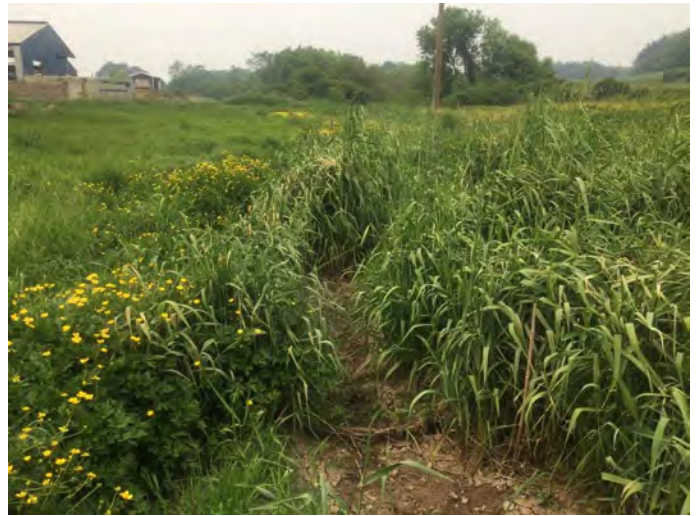
Mudcracks, change in vegetation density, break in slope.

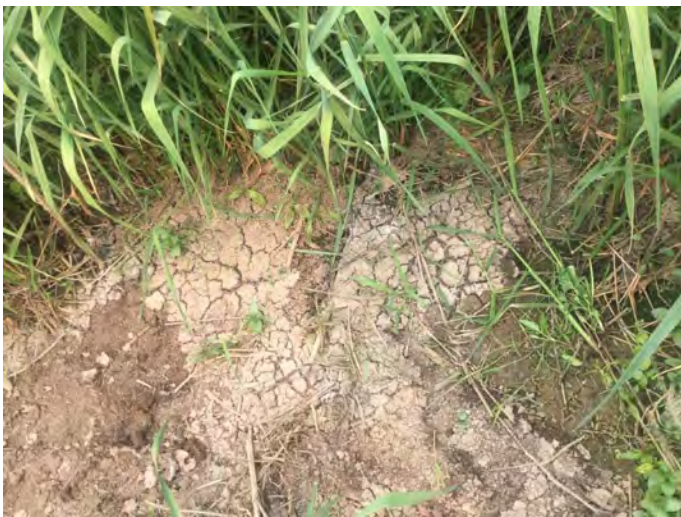
Mud cracks, change in vegetation type and density.

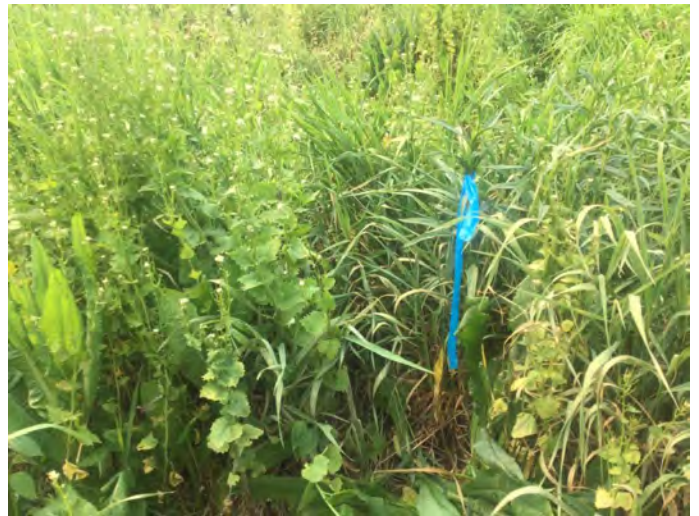
stream hidden under vegetation.

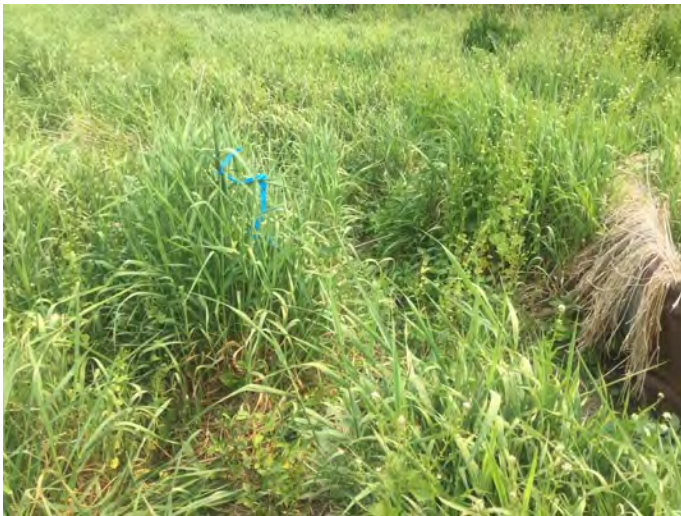
stream hidden under vegetation.

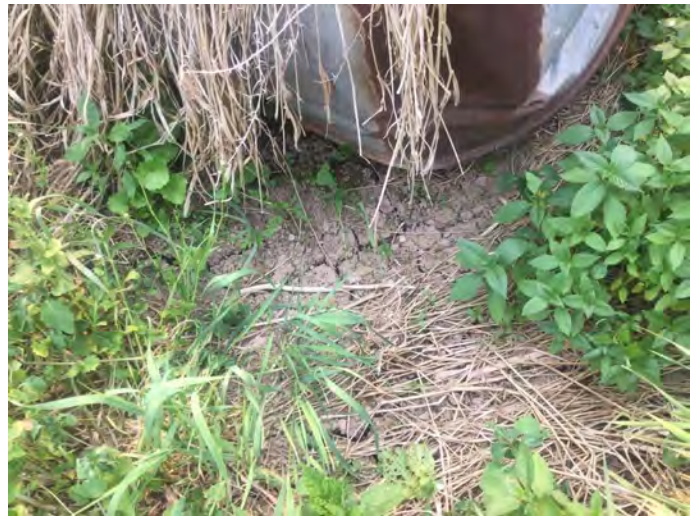
mud cracks near culvert, change in vegetation.

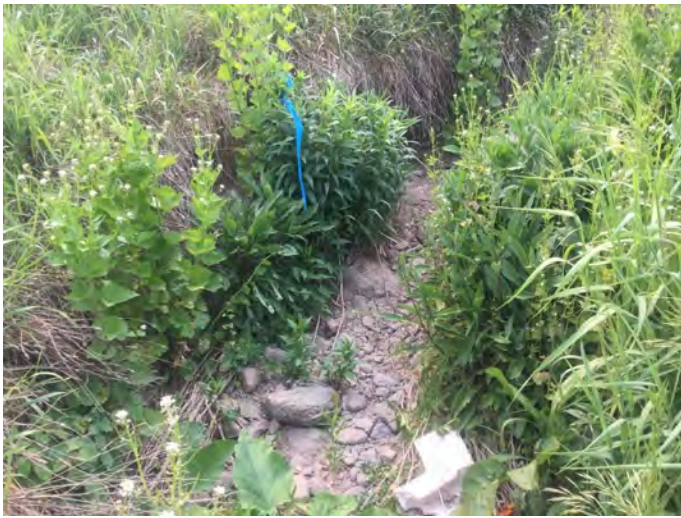
change in vegetation, mud cracks, break in slope

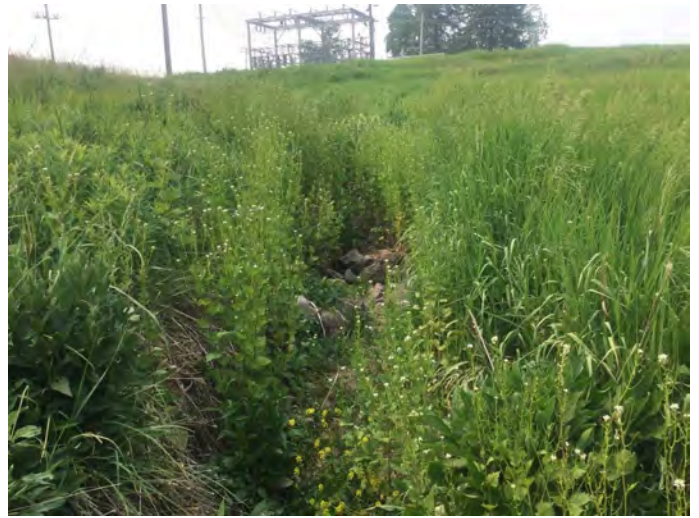
change in vegetation.

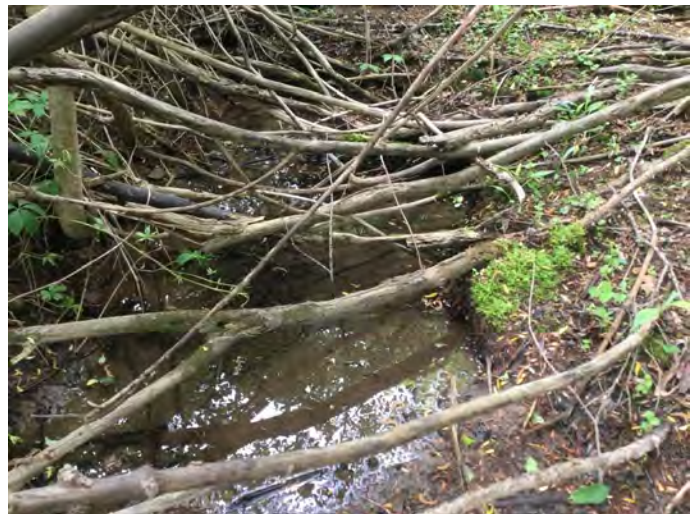
subtle break in slope and change in vegetation.

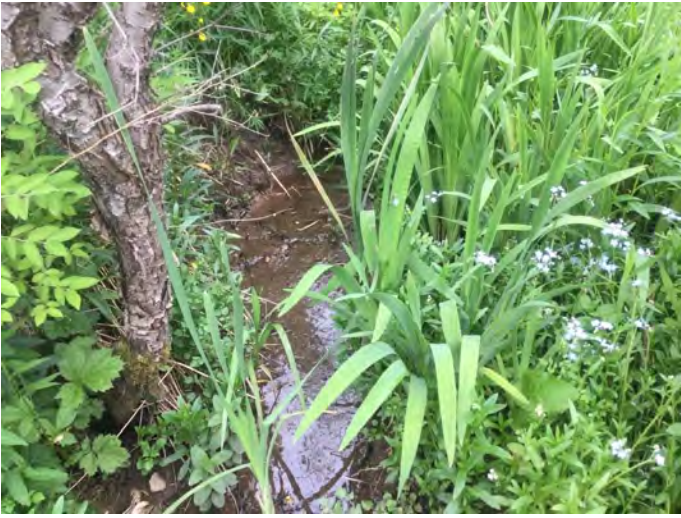
Change in vegetation.

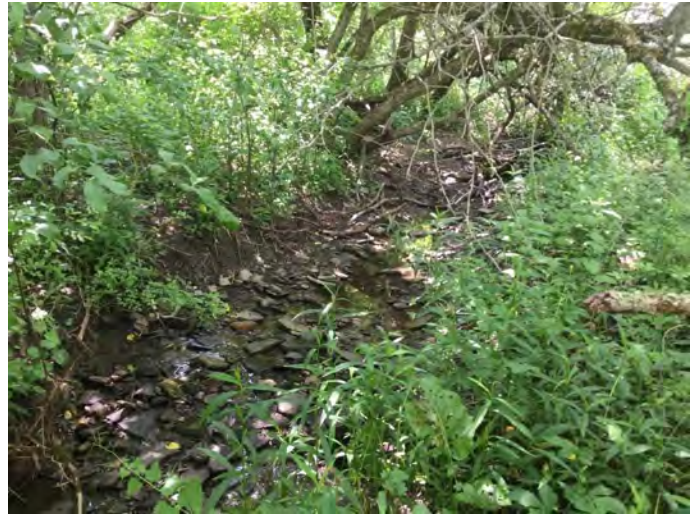
Break in slope, change in vegetation type, change in particle size distribution.

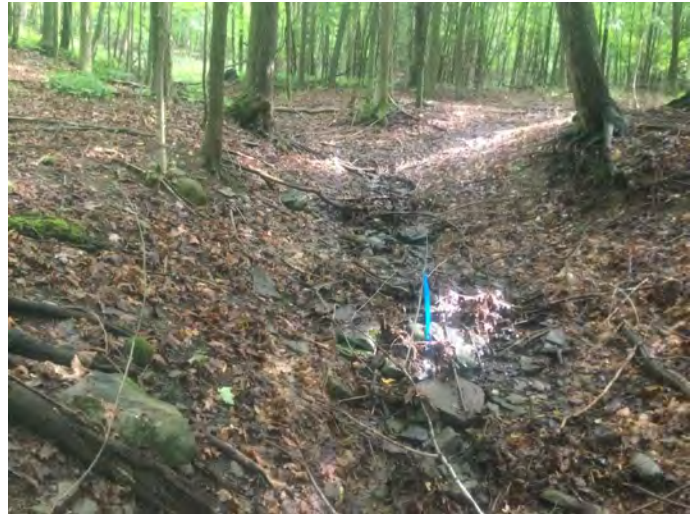
Break in slope, change in particle size, wracking.

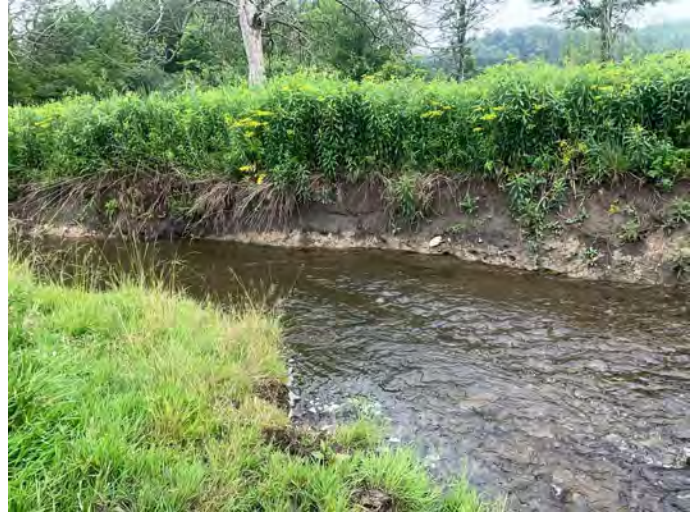
Break in slope, change in vegetation type and density.

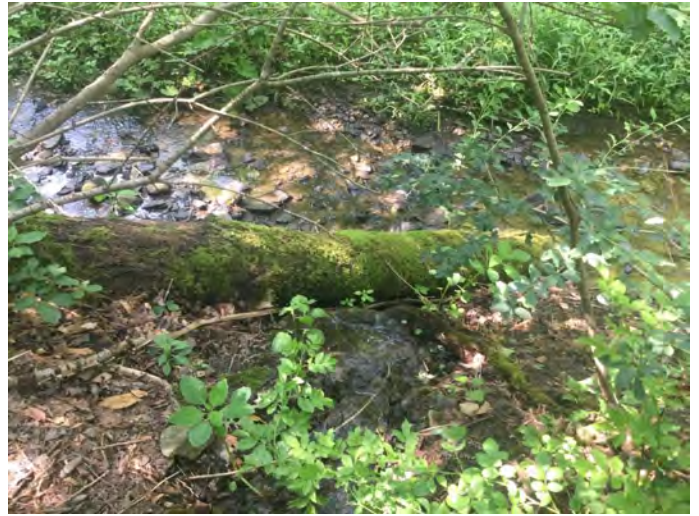
view showing change in particle size of stream bed, vegetation transition, and break in slope.

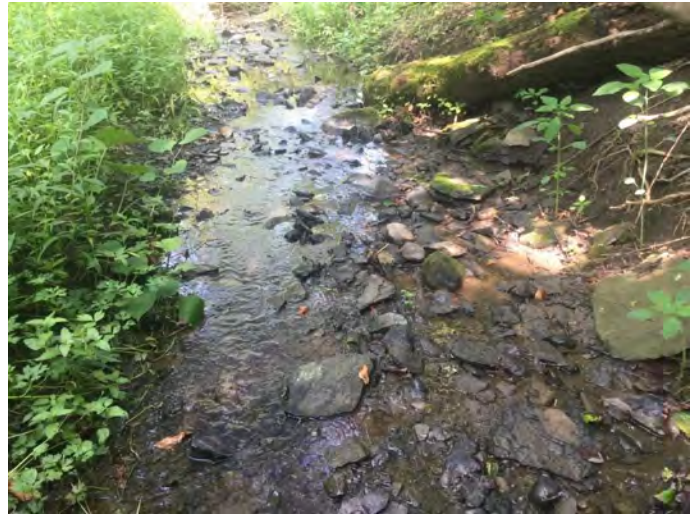
Break in slope, change in vegetation type and density, change in particle size distribution.

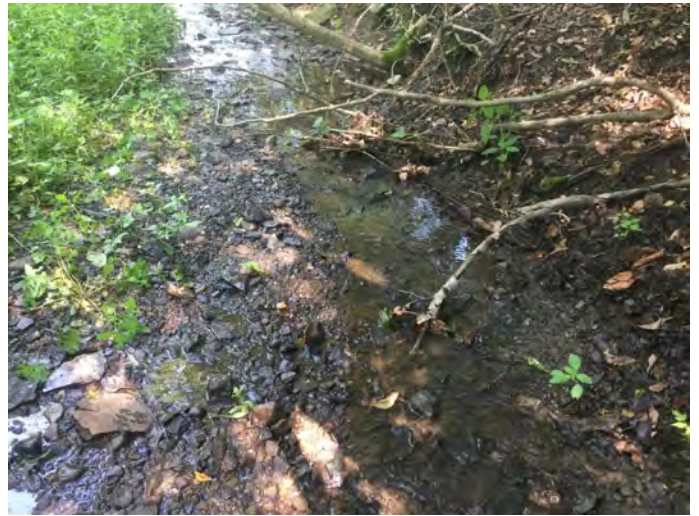
Depositional bar forming in inside of stream bed.

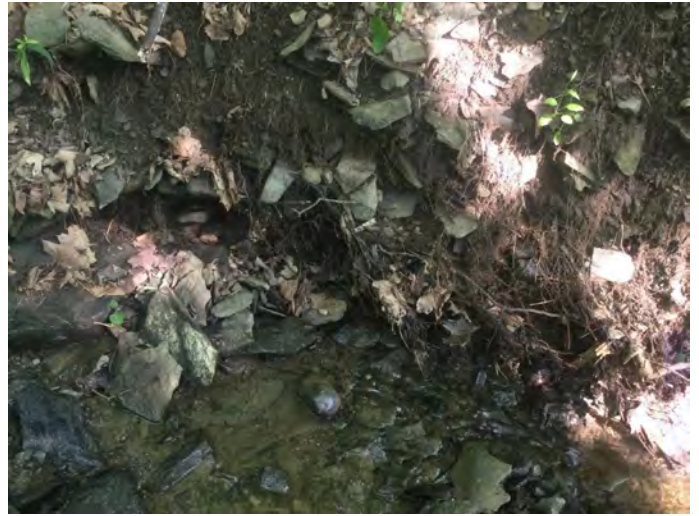
abrupt break in slope

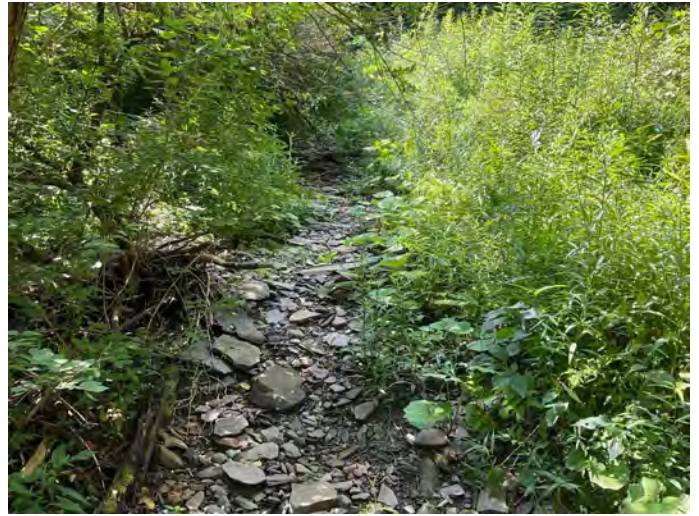
Change in particle size distribution, change in vegetation type and density.

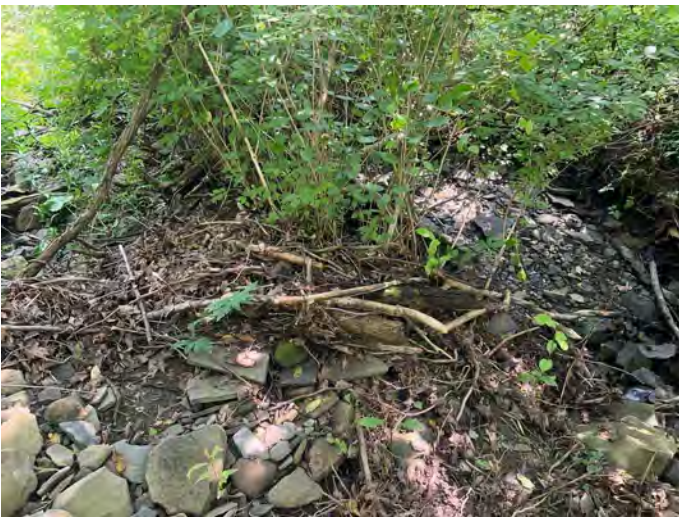
Wracking

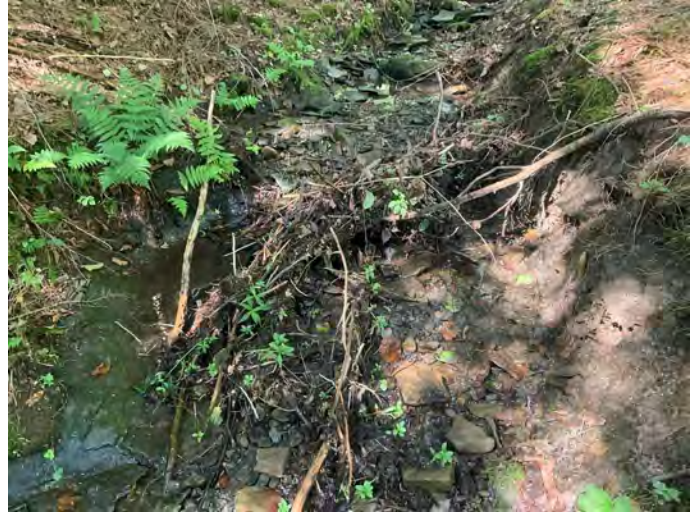
Wracking, break in slope, change in particle size distribution

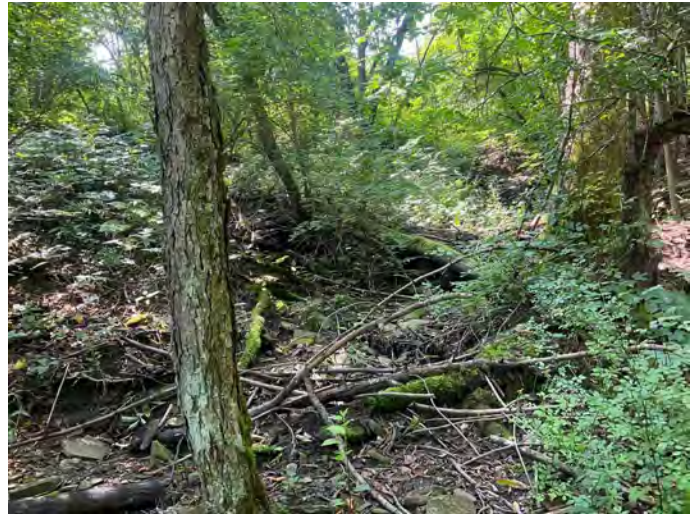
wracking

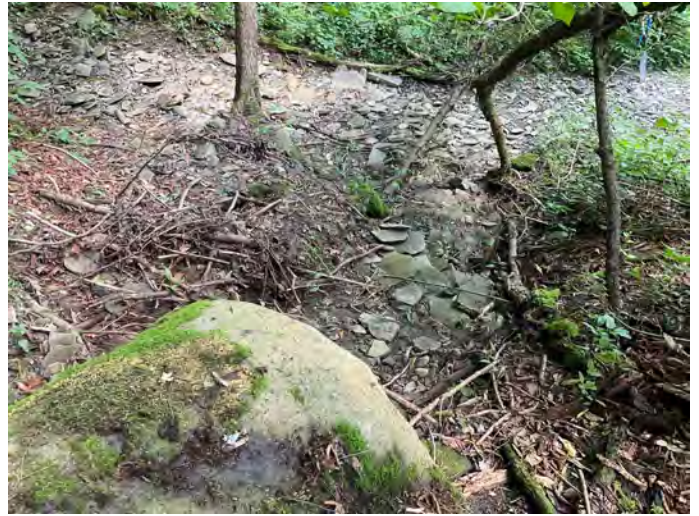
break in slope, change in particle size distribution.

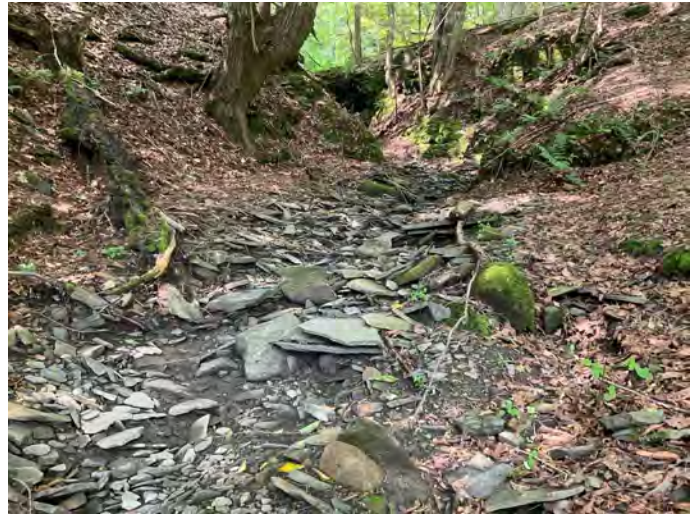
Break in slope, change in particle size.

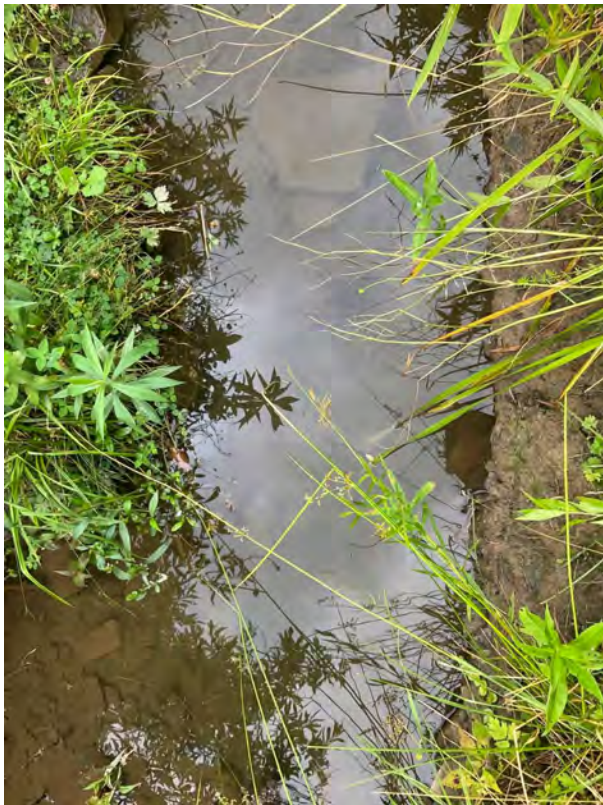
substrate; gravel

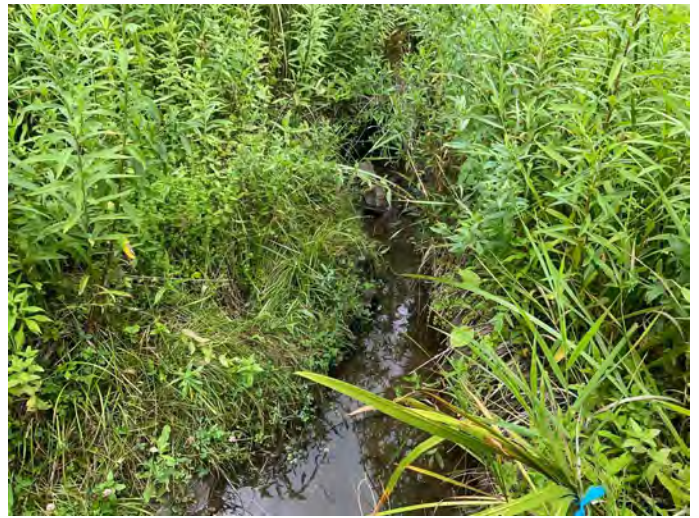
Upstream and shelving

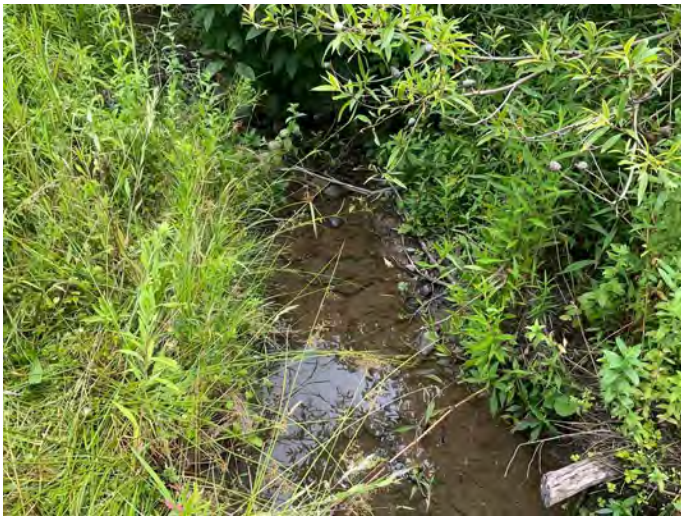
Downstream and absent vegetation

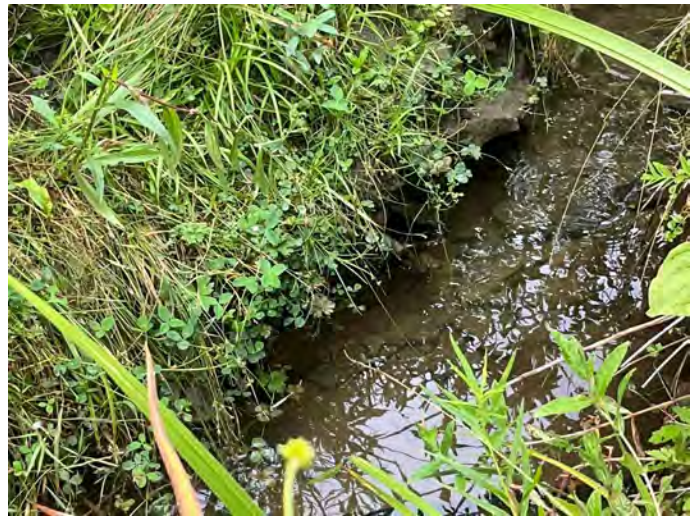
Undercut banks
