- Rapid Ordinary High Water Mark (OHWM) 1.0

Project	21028 Hoffman Falls Wetland Delineation
ID	352398
Survey Date	06/01/2023
User	Rachael Foote

Towns of Fenner, Nelson, Eaton, and Smithfield, Madison County, New York

Wetland and Stream Delineation Report

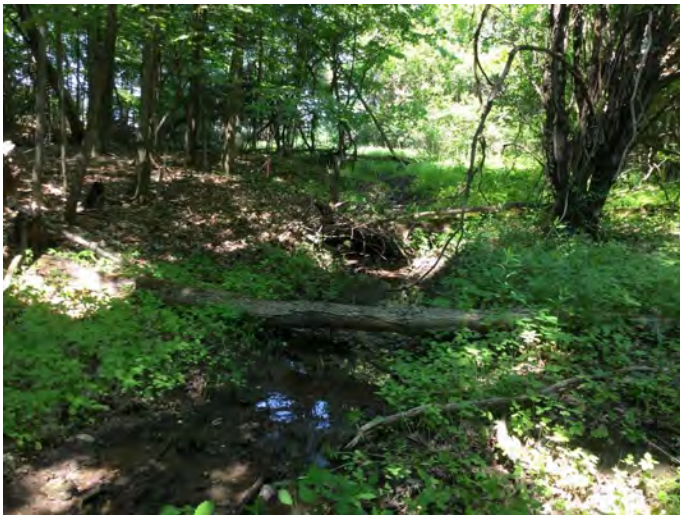
Upstream photograph with break in slope and vegetation transition present.

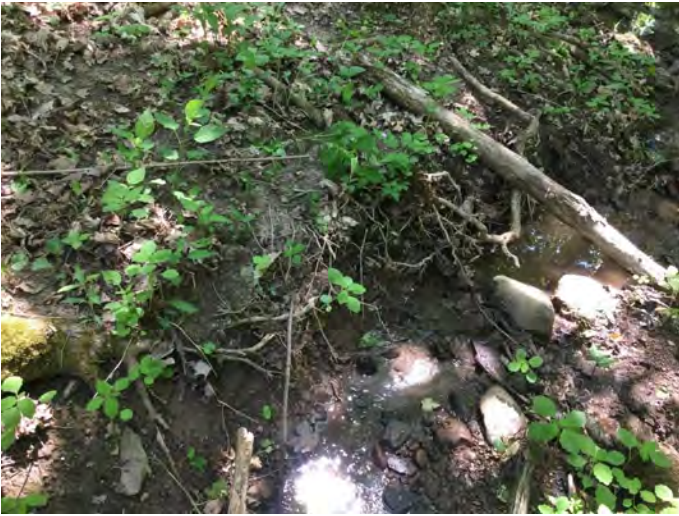
Exposed roots within intact soils layer and break in slope present.

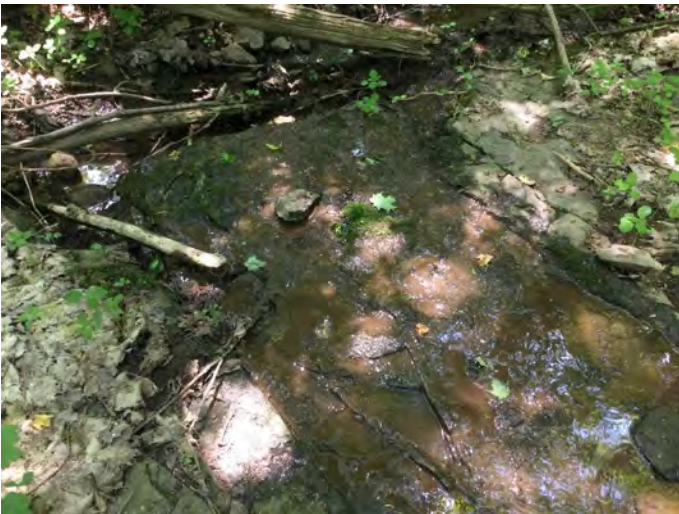
Evidence of bedload erosional forces occurring below the OHWM within bedrock substrate of streambed.

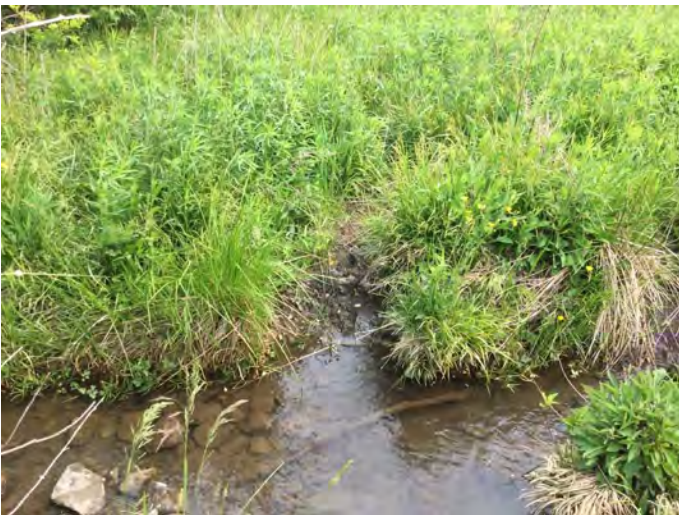
Break in slope, change in particle size distribution, change in vegetation type and density.

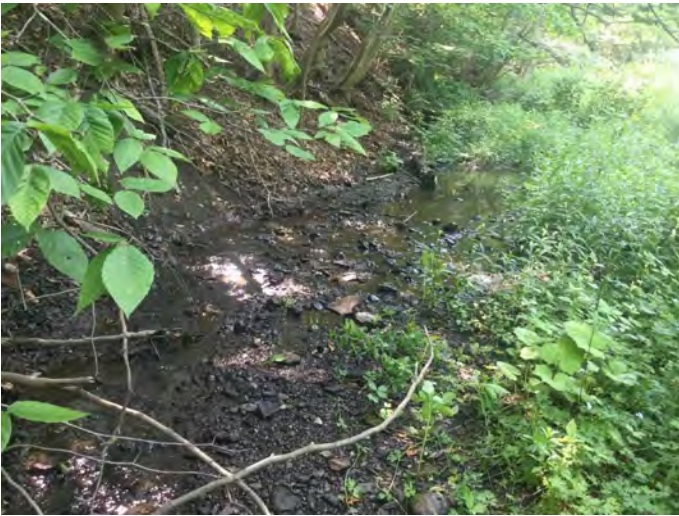
Break in slope, change in vegetation type and density, change in particle size distribution.

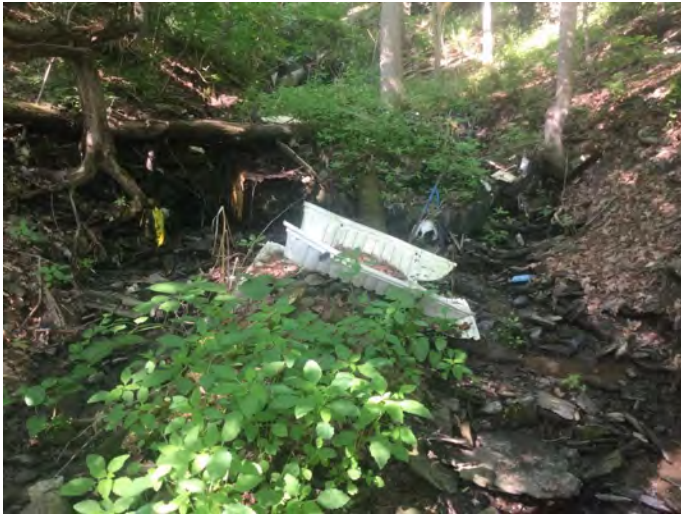
channel bar, break in slope, change in particle size distribution, change in vegetation type and density

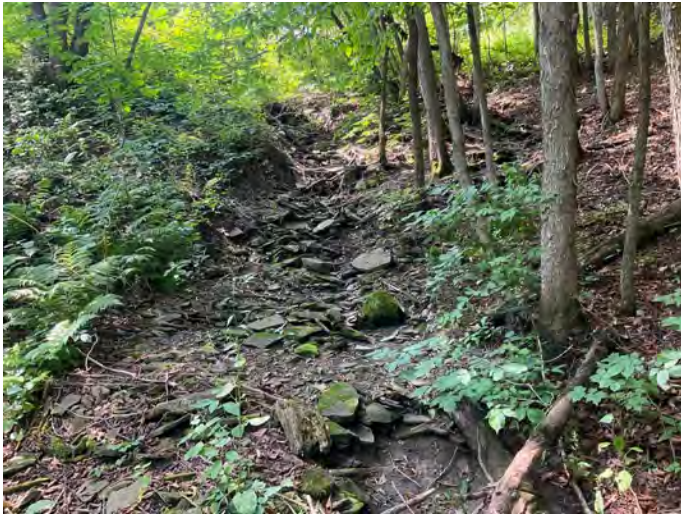
break in slope, change in particle size distribution, change in vegetation density.
