- Rapid Ordinary High Water Mark (OHWM) 1.0

Project	21028 Hoffman Falls Wetland Delineation
ID	352398
Survey Date	06/01/2023
User	Rachael Foote

Towns of Fenner, Nelson, Eaton, and Smithfield, Madison County, New York

Wetland and Stream Delineation Report

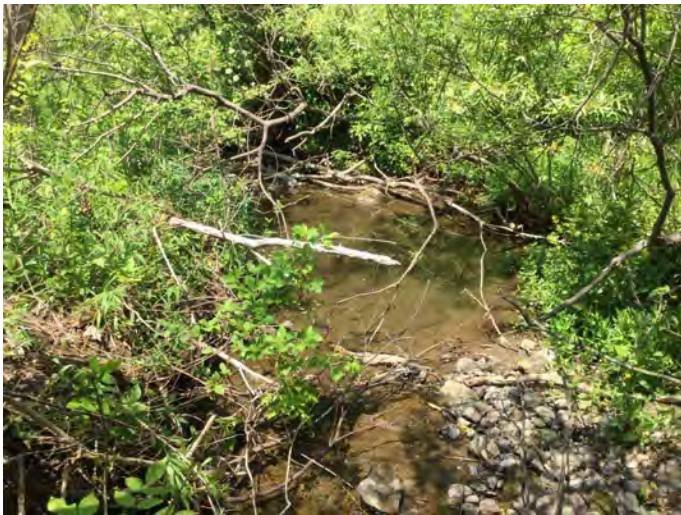
Upstream photograph.

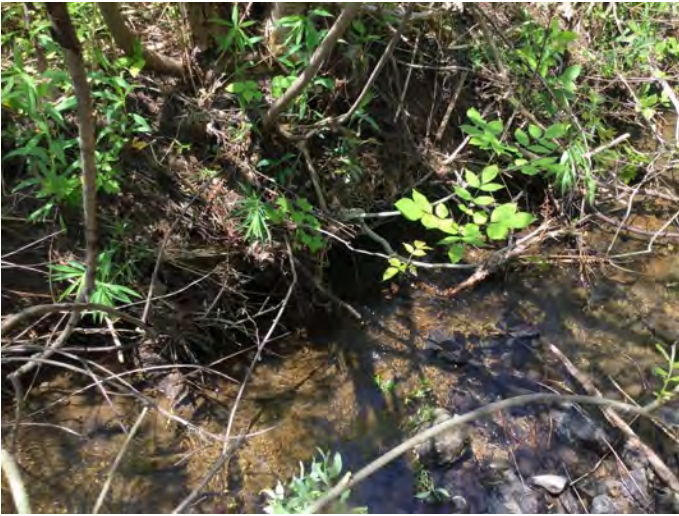
Undercut bank.

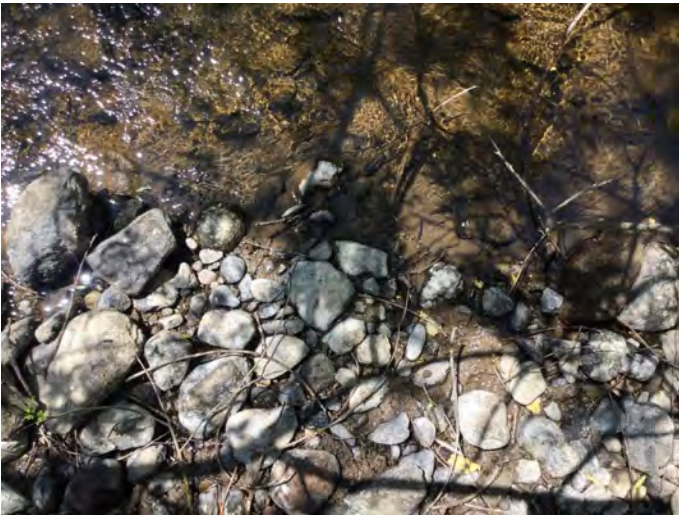
Transition in substrate type and point bar.

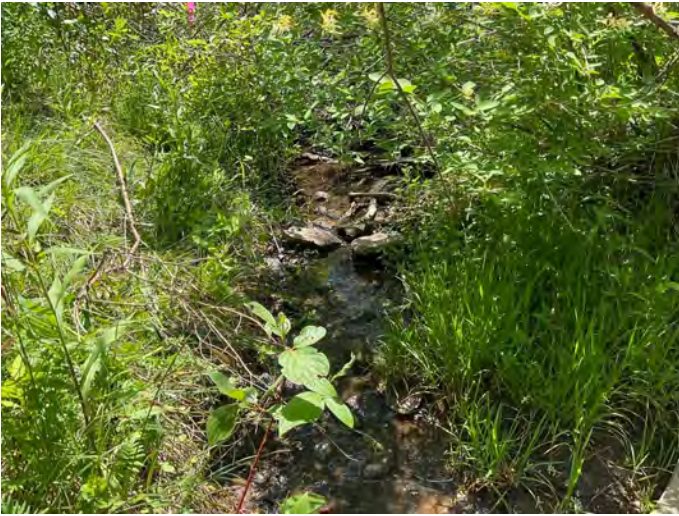
Photo of stream flowing within the PSS wetland complex.

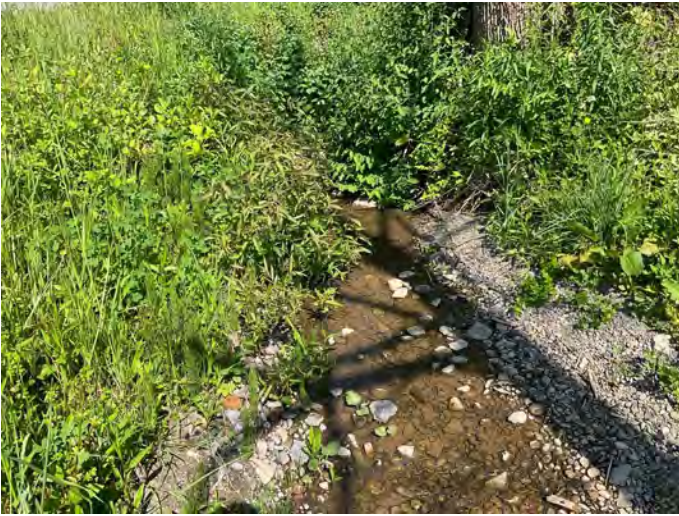
Upstream photo, with vegetation transition present.

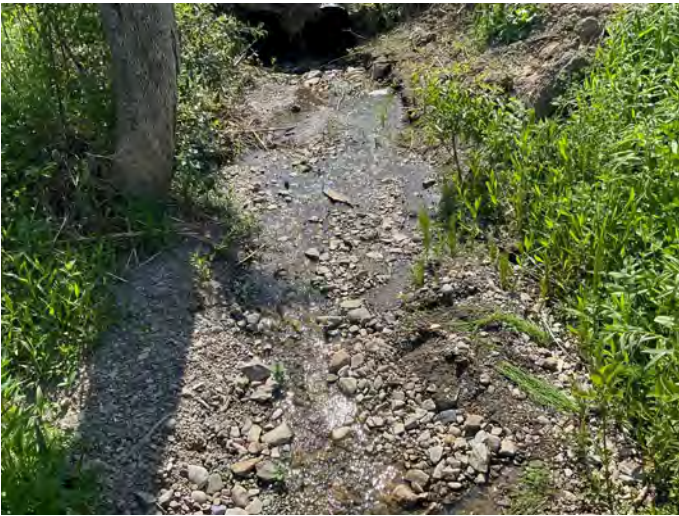
Downstream photo, with vegetation transition present.

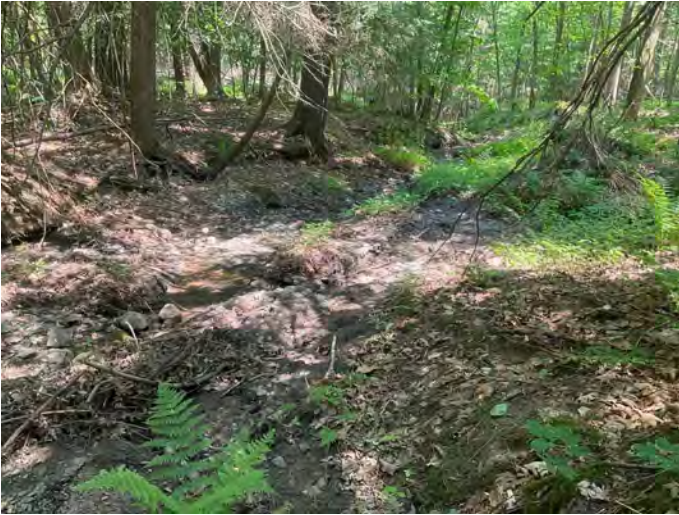
Break in slope, change in particle size distribution.

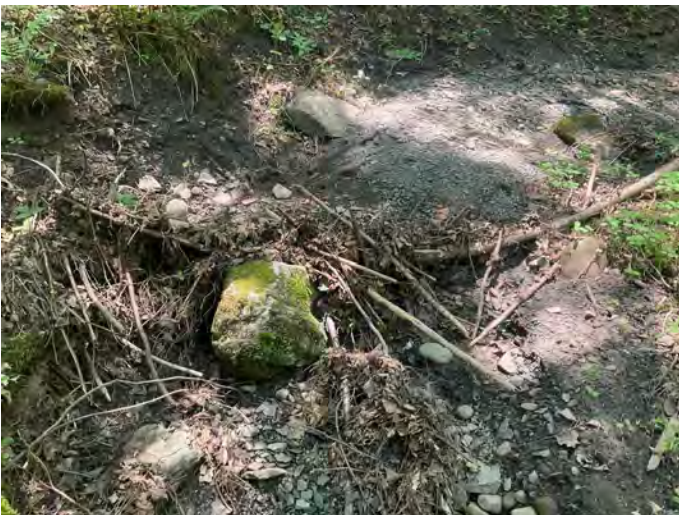
wracking, change in particle size distribution, break in slope.

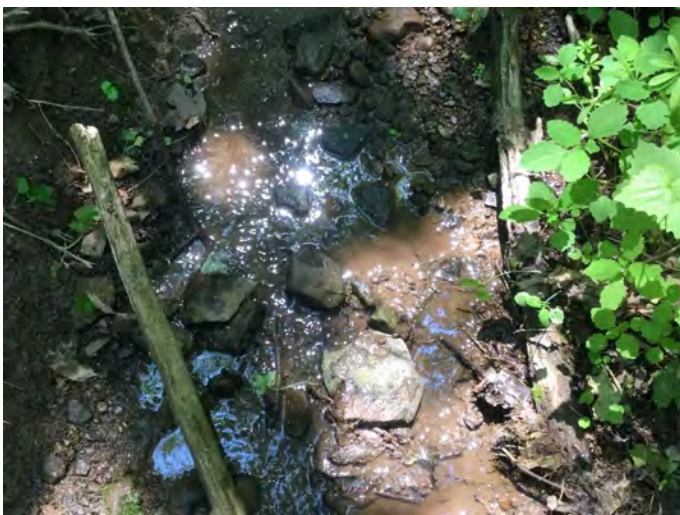
Stream substrate photo.

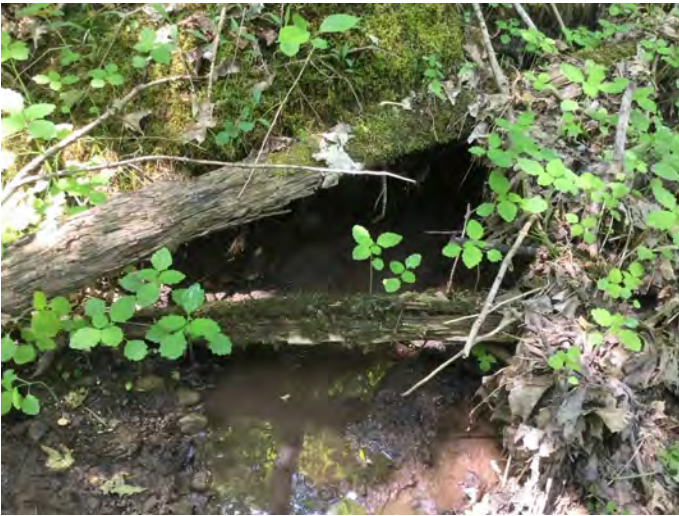
Presence of woody material above the OHWM.

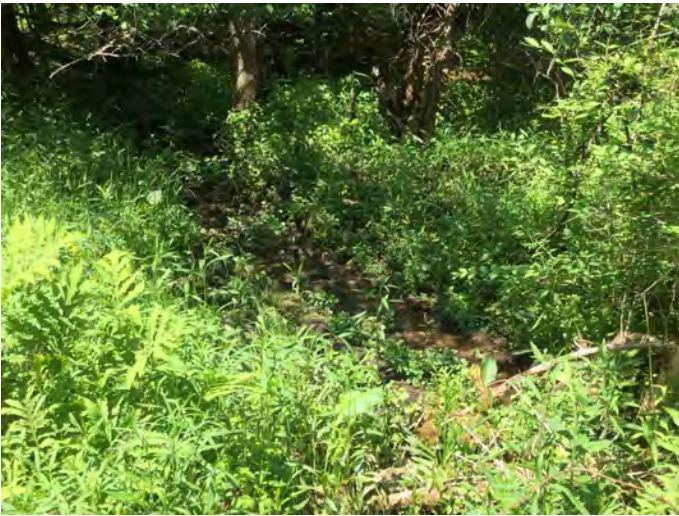
Upstream photograph with transition in vegetation.

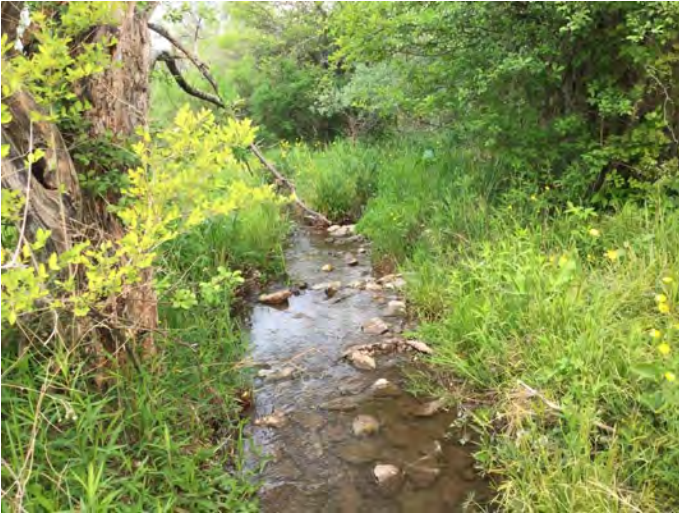
Break in slope, change in particle size distribution, change in vegetation type and density.

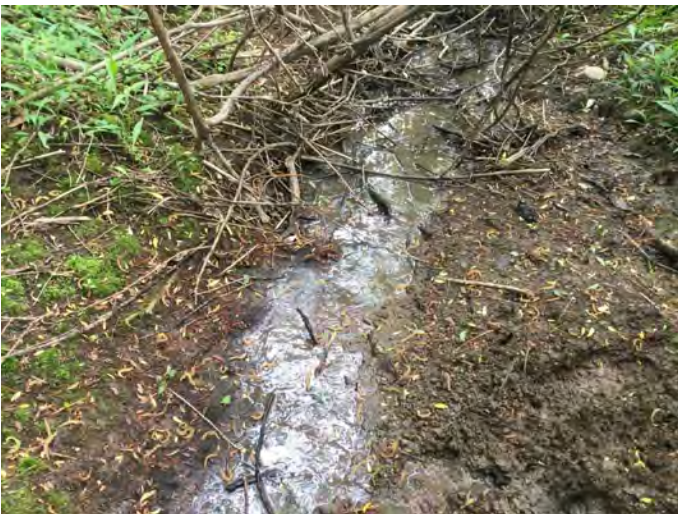
Change in vegetation.

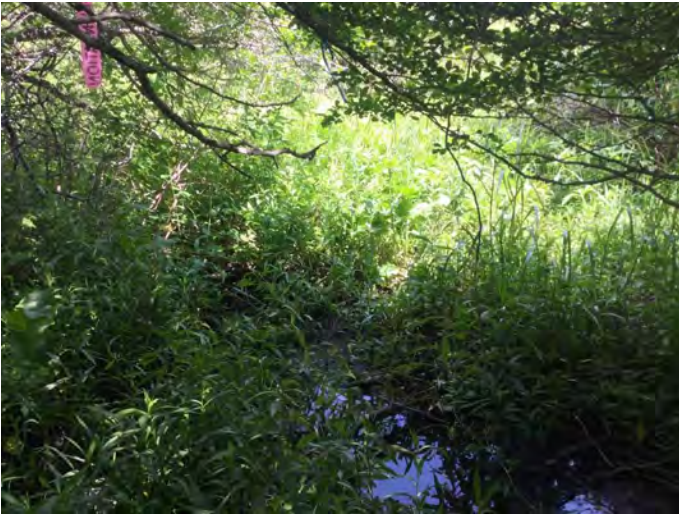
View of change in vegetation type.

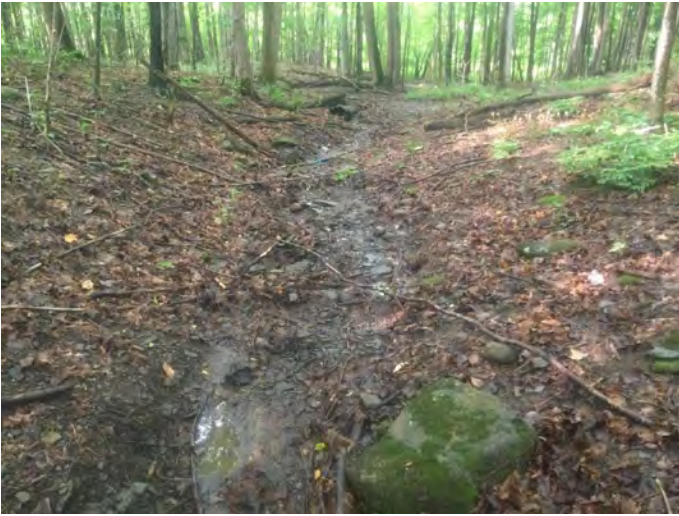
Break in slope, change in particle size, wracking.

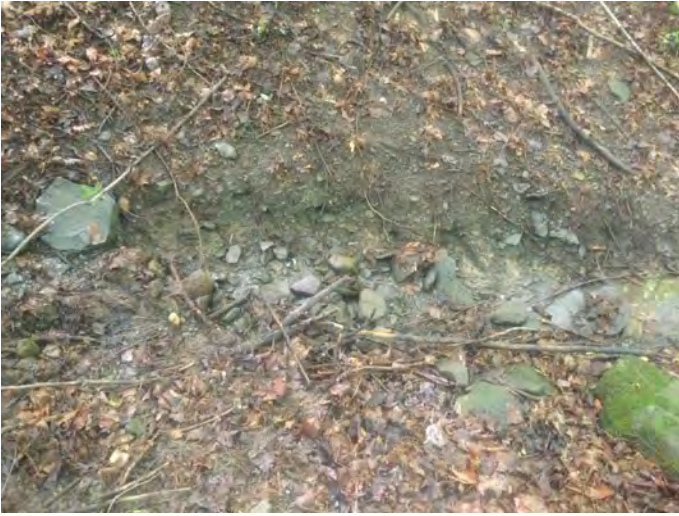
Break in slope, change in particle size, wracking.

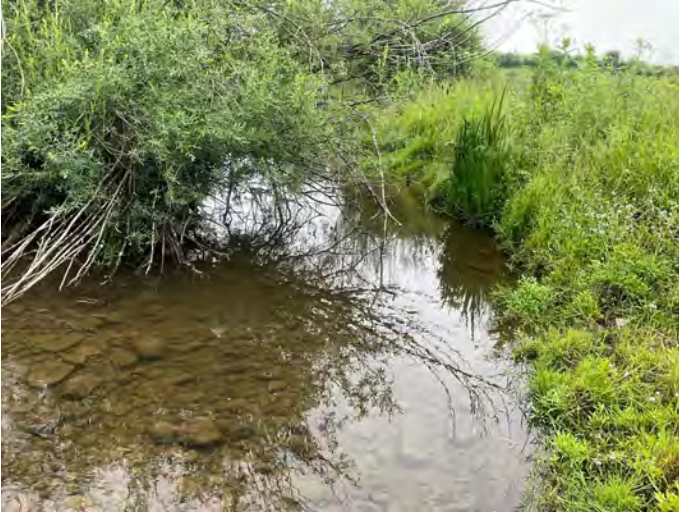
change in vegetation type and density, break in slope.

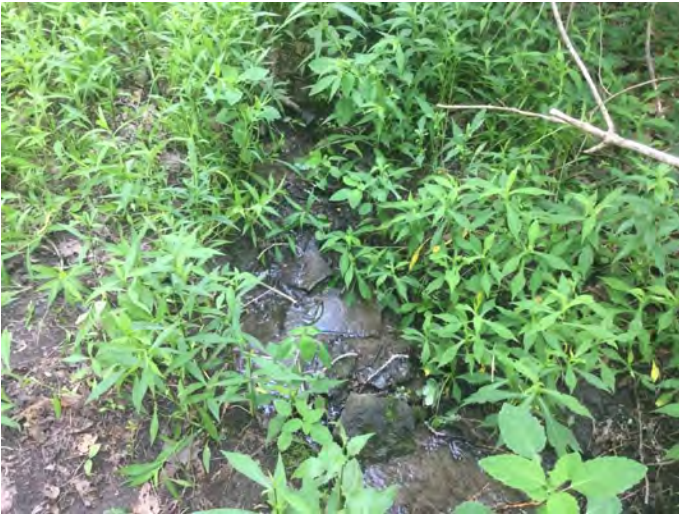
change in vegetation type and density, change in particle size distribution.

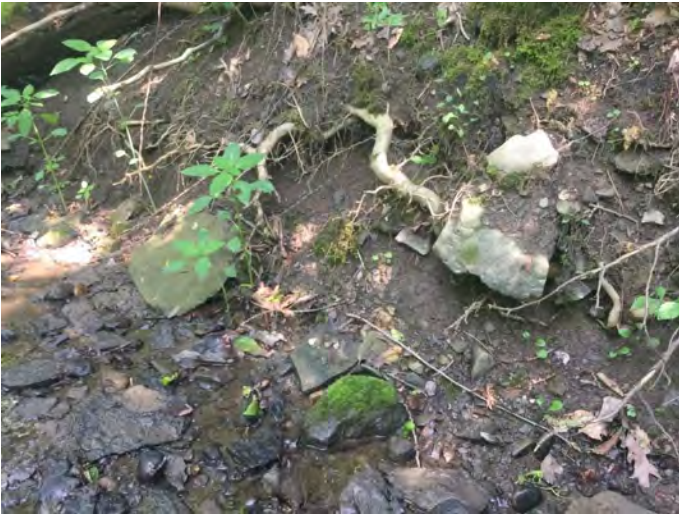
Exposed roots

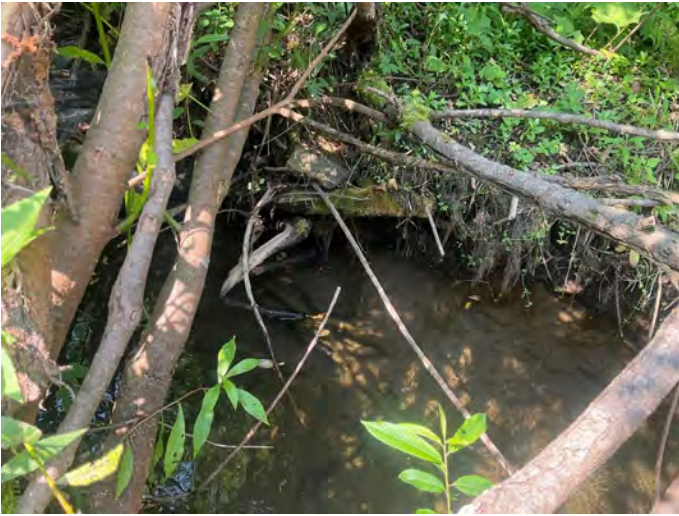
Undercut bank.

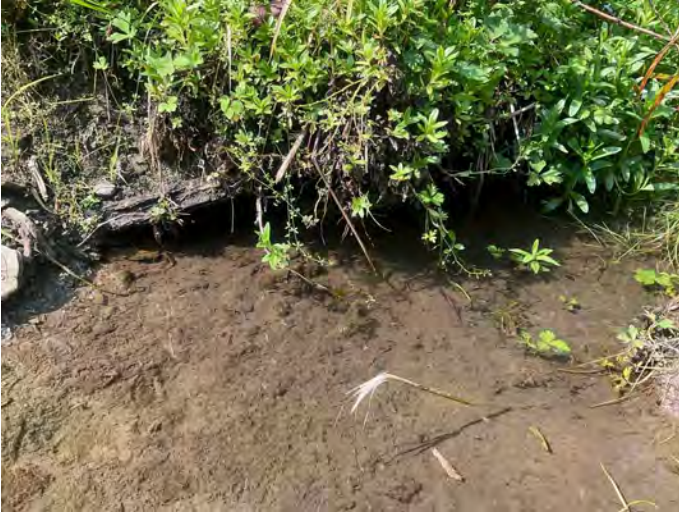
Undercut bank

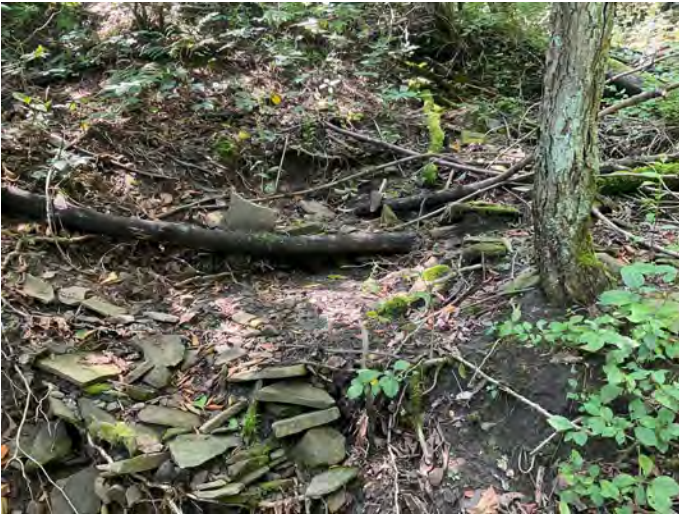
Break in slope, change in particle size, and wracking.

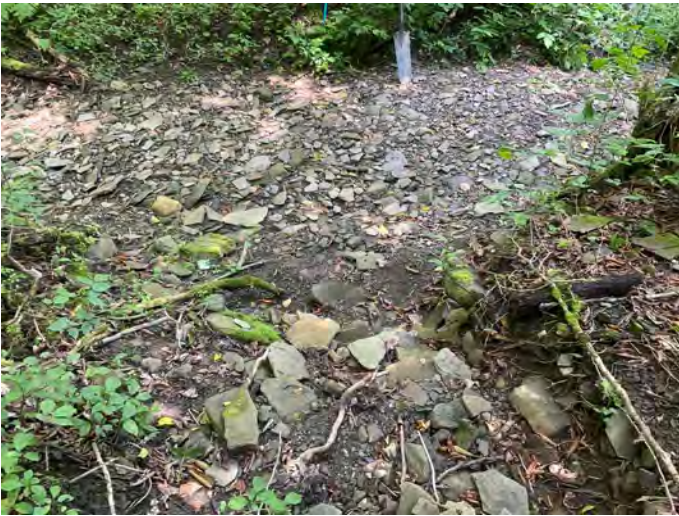
Change in particle size, break in slope.

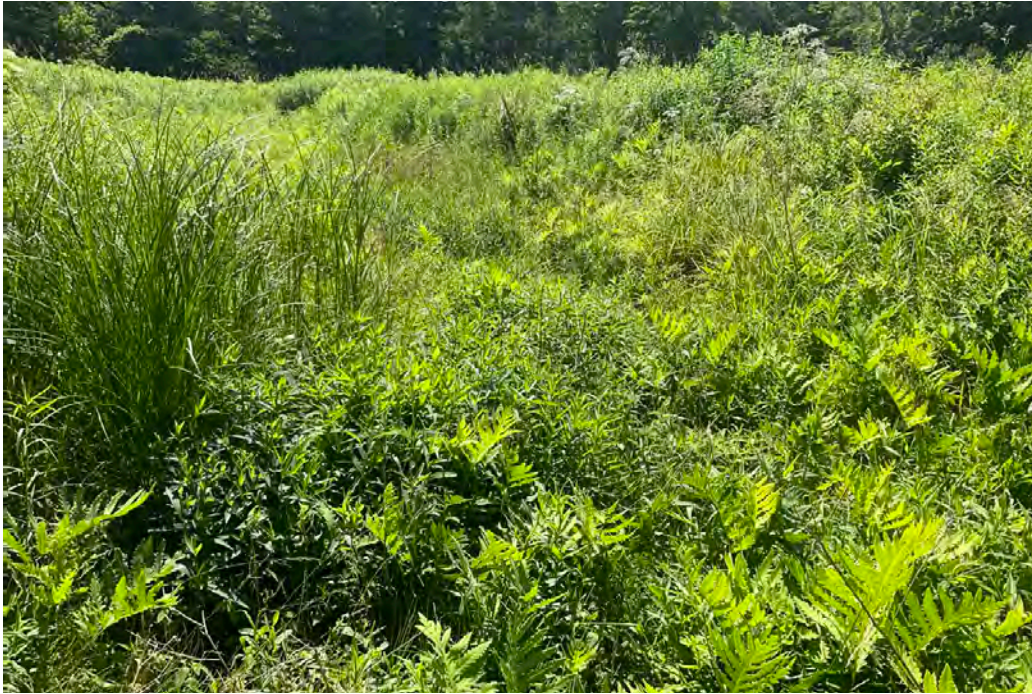
Photo 1

Representative photo of palustrine emergent (PEM) wetlands

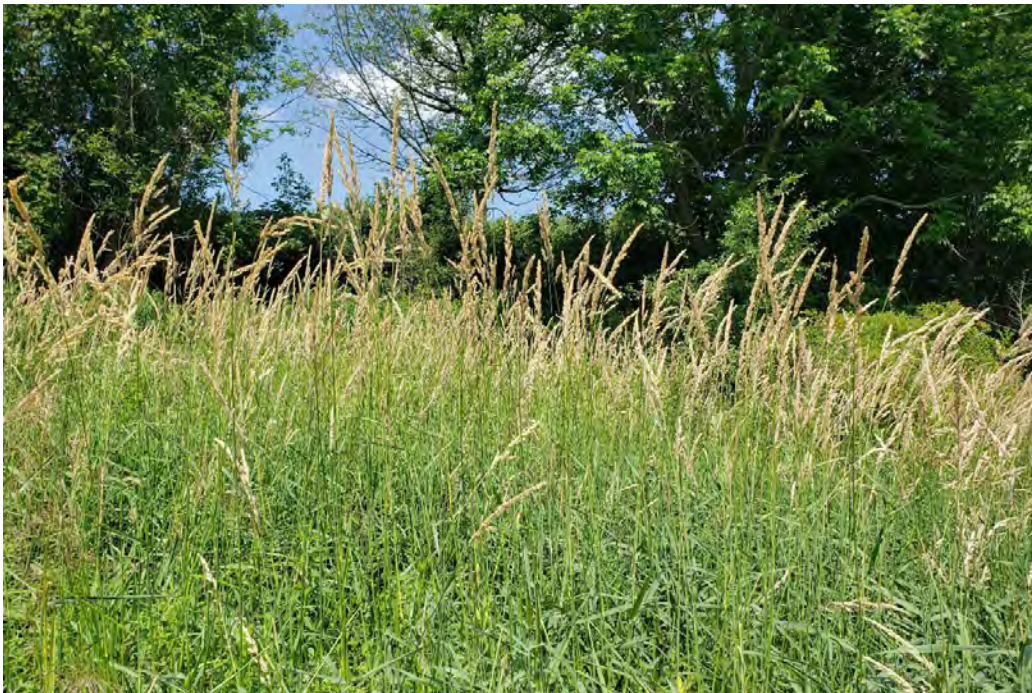
Photo 2

Representative photo of palustrine emergent (PEM) wetlands

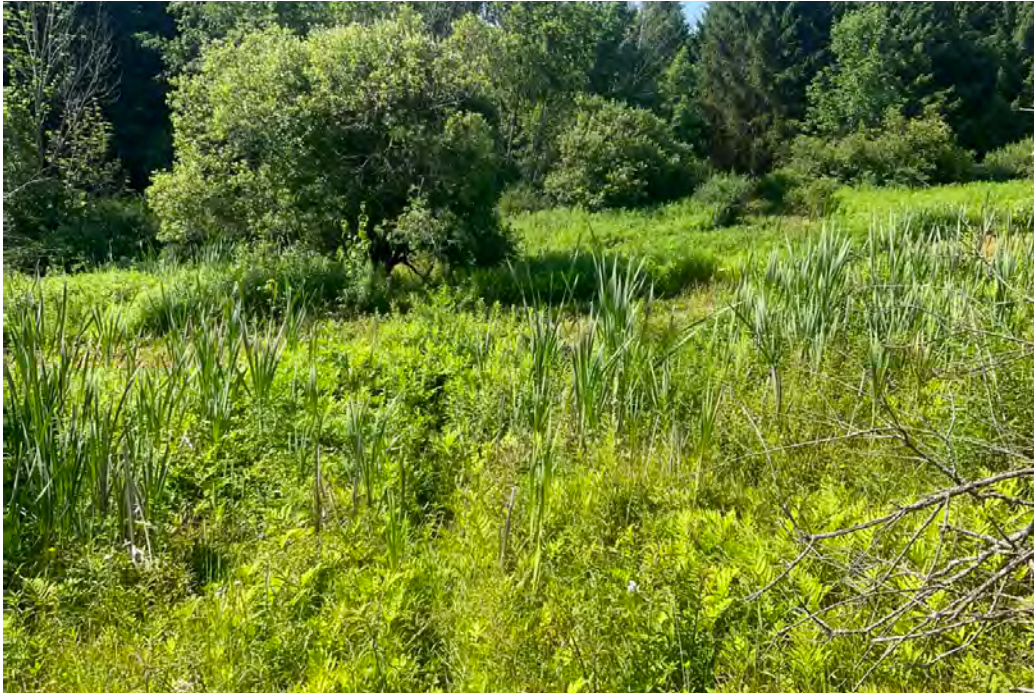
Photo 3

Representative photo of palustrine emergent (PEM) wetlands
